U.S.S. MONITOR

A FINAL REPORT
ON 1979 SITE TESTING IN THE MONITOR NATIONAL MARINE SANCTUARY

BY GORDON P. WATTS, JR.
NORTH CAROLINA DEPARTMENT OF CULTURAL RESOURCES

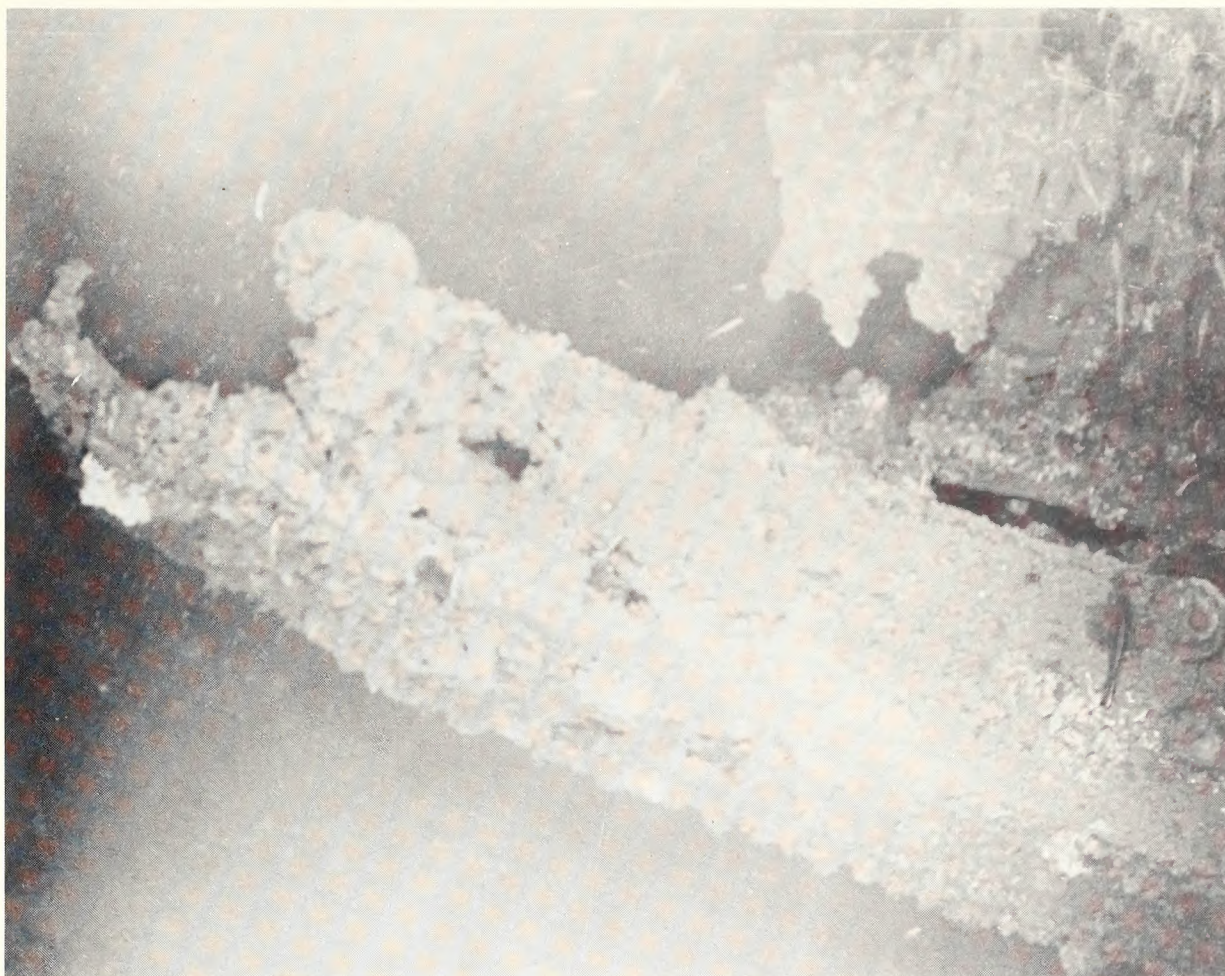
Figure 19. Aft of the present location of the turret, both the port (above) and starboard armor belts have been extensively damaged.

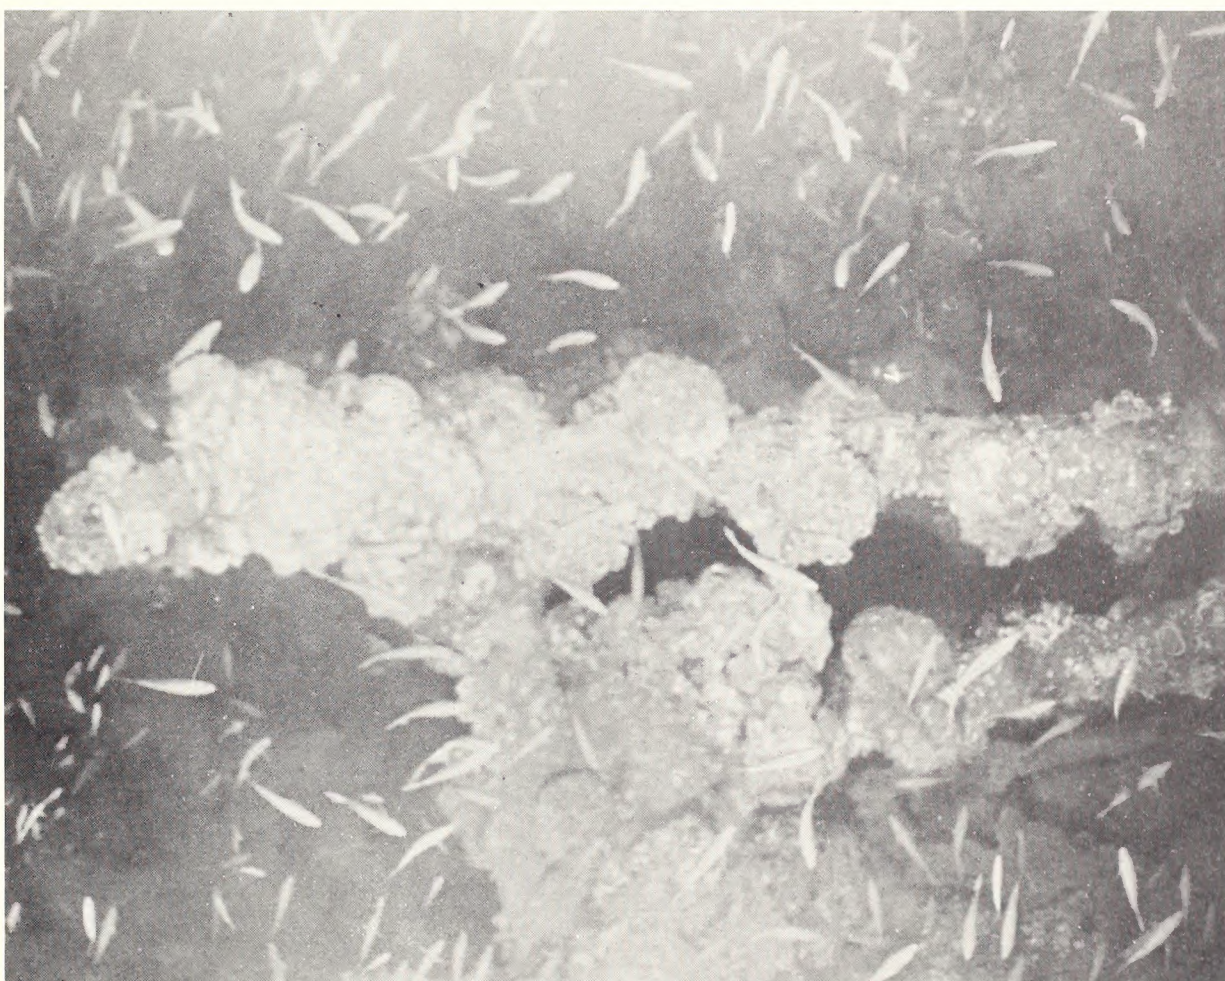
Figure 20. Although displaced by damage to the stern and obscured by heavy fouling the propeller, propeller support yoke, and skeg survive intact.

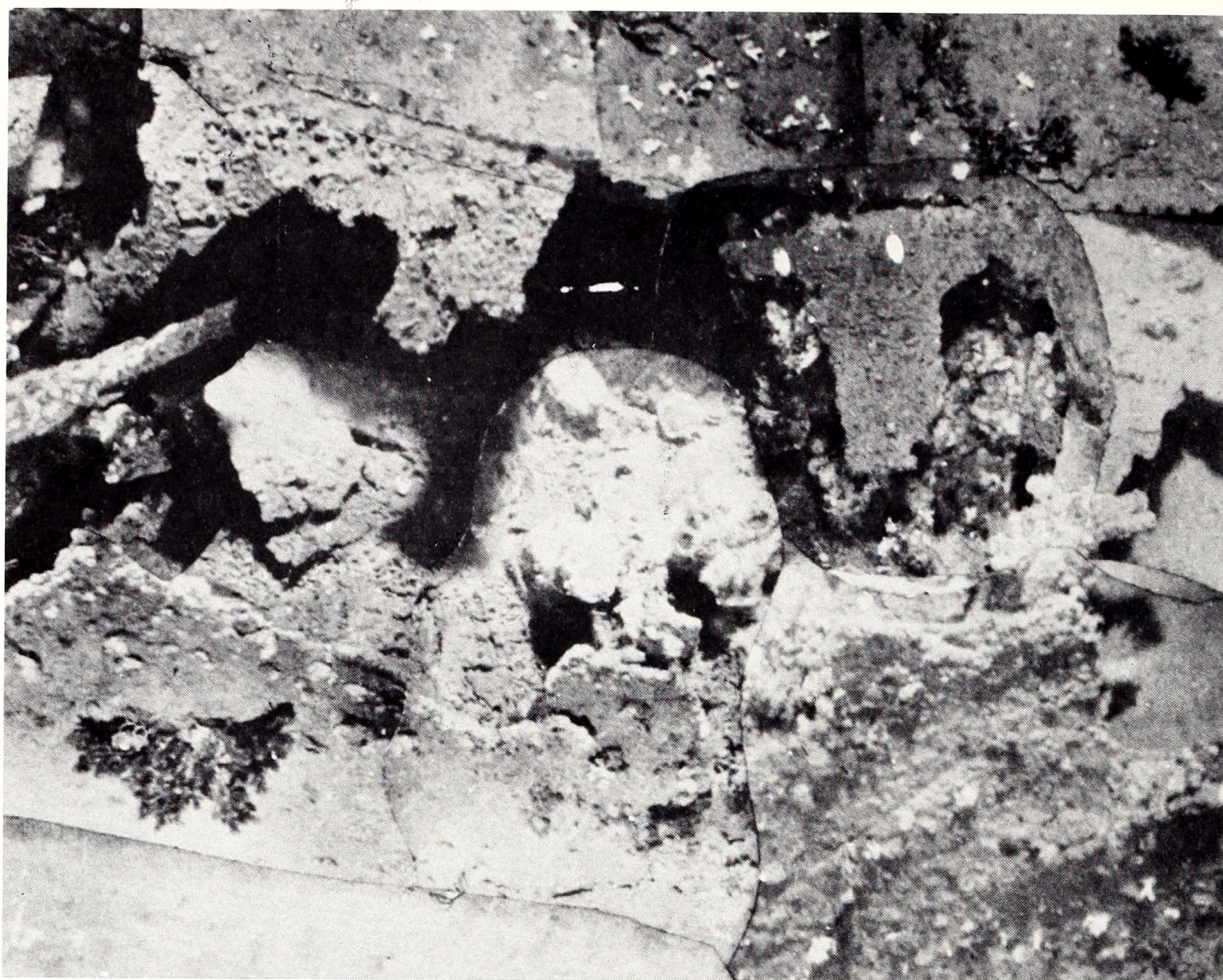
Forward of the amidships bulkhead damage has been more extensive. The entire displacement hull has collapsed. With the exception of the vicinity of the pilot house and limited areas immediately inboard of the port armor belt, plating, associated frames and floors, and other structural iron fragments have covered the interior of the ship (*Figure 21*). Approximately 50 feet aft of the bow and immediately forward of the amidships bulkhead inboard of the port armor belt, the deck was ruptured, leaving extensive holes in the structure (*Figure 22*). In these areas and those not obscured by remains of the displacement hull, additional exposed material has been identified as portions of the interior of the vessel, equipment and fittings that were stowed below the crew's quarters and ward room, and associated artifacts.

Figure 21. Forward of the amidships bulkhead, structural material from the lower hull has collapsed to cover the interior of the wreck.

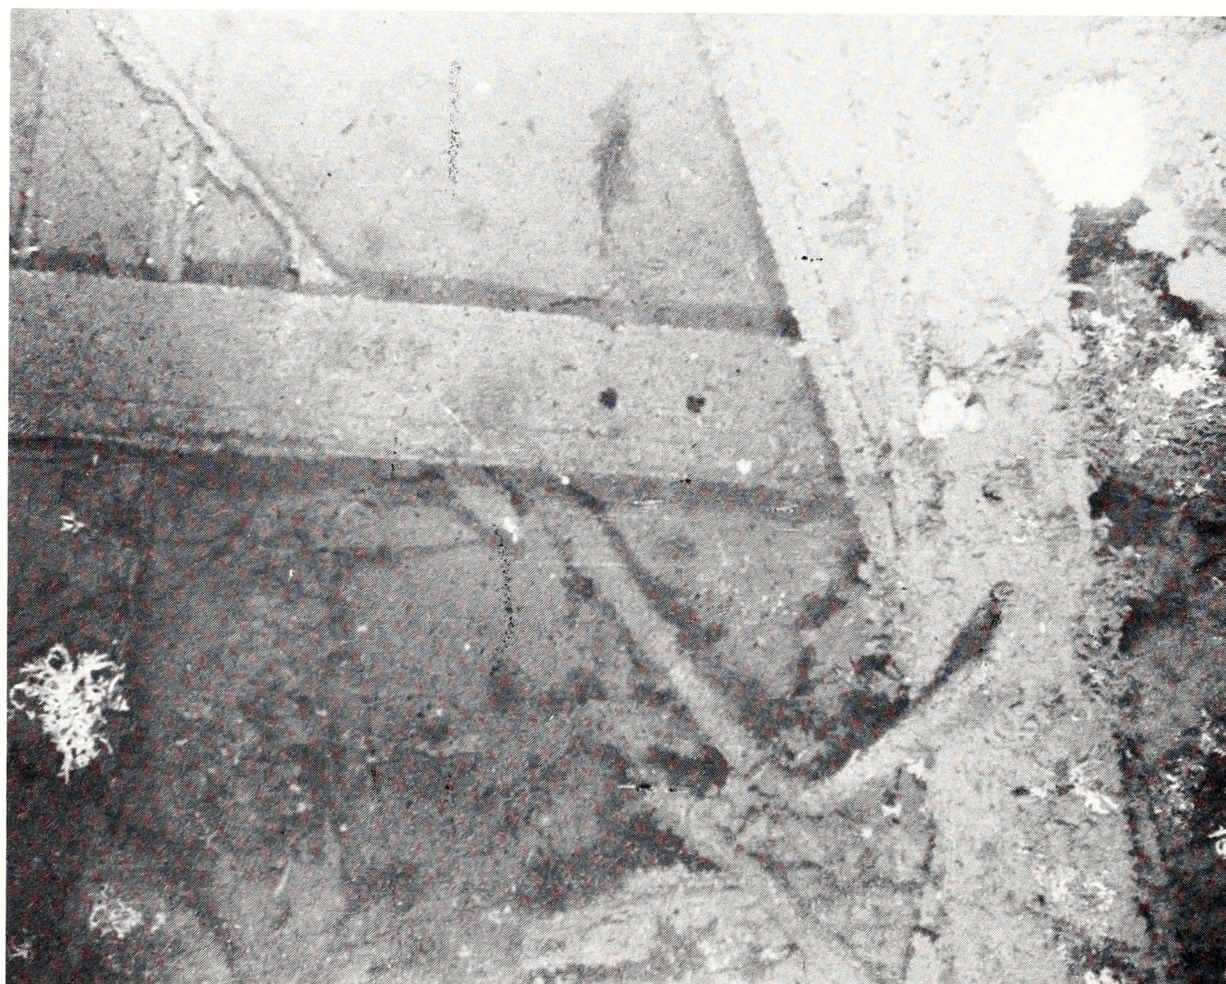
Figure 22. Below displaced "floors" the wardroom deck has ruptured to reveal sediment below the remains of the *Monitor*.

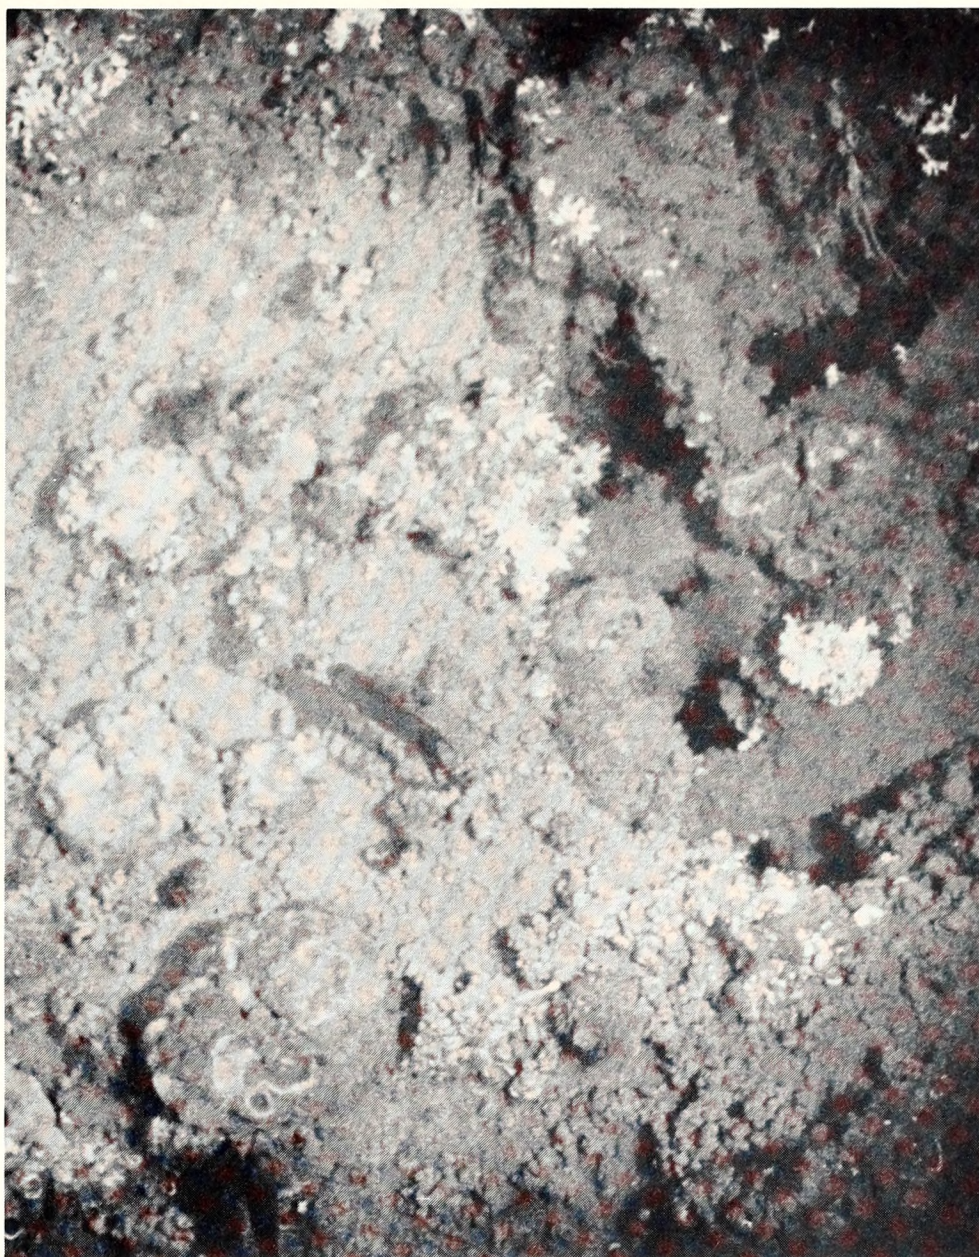
From the circular anchor well forward of the pilot house structure anchor chain leads over the armor belt and into the sediment toward the south (*Figure 23*). A series of frames protruding from the sediment identify the location of the armor belt aft of the point where it disappears into the sediment. With the exception of ruptures in the deck structure the armor plate forward of the amidships bulkhead appears to be intact.

Figure 23. Heavily concreted anchor chain from the *Monitor*'s distinctive circular anchor well leads across the underside of the starboard armor belt and into the sediment south of the wreckage.

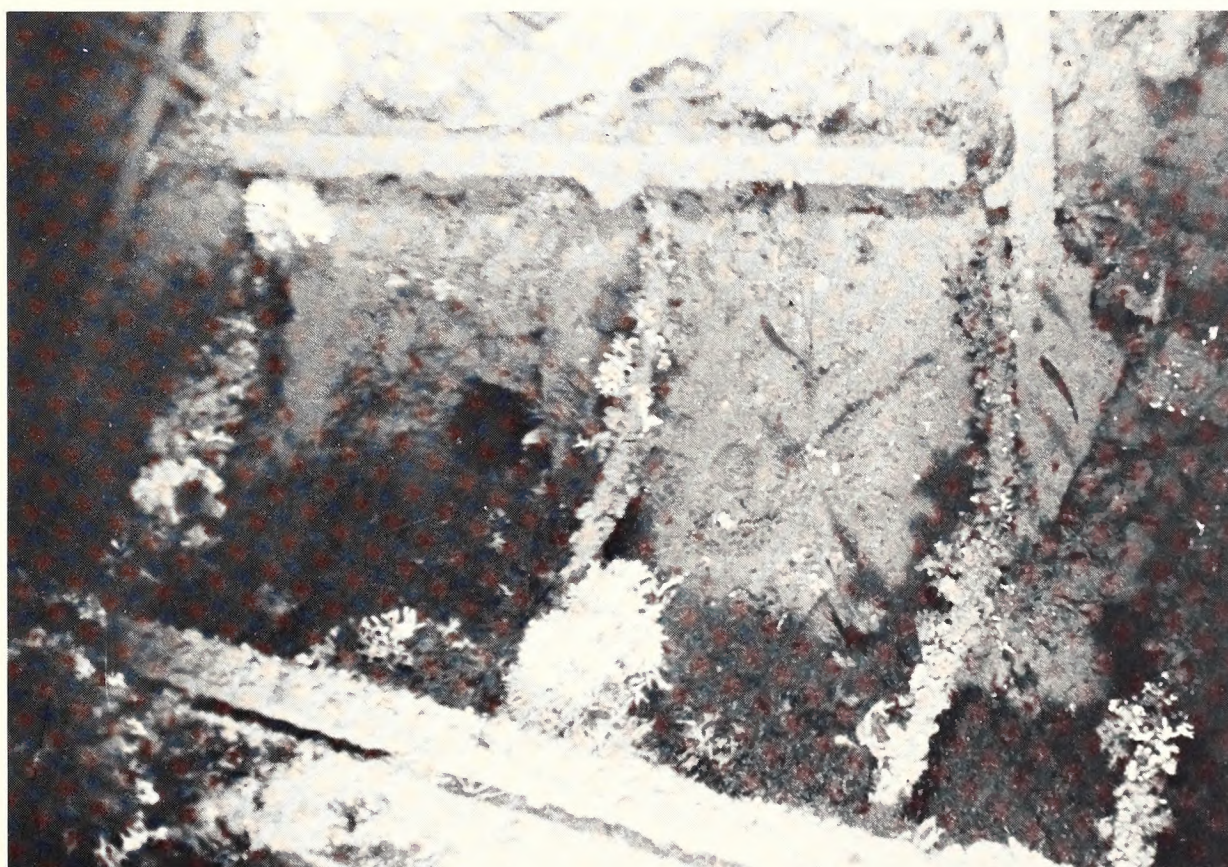
Figure 36. Inside the port armor belt (lower left corner), deteriorated coal bunkers revealed an open coal scuttle.

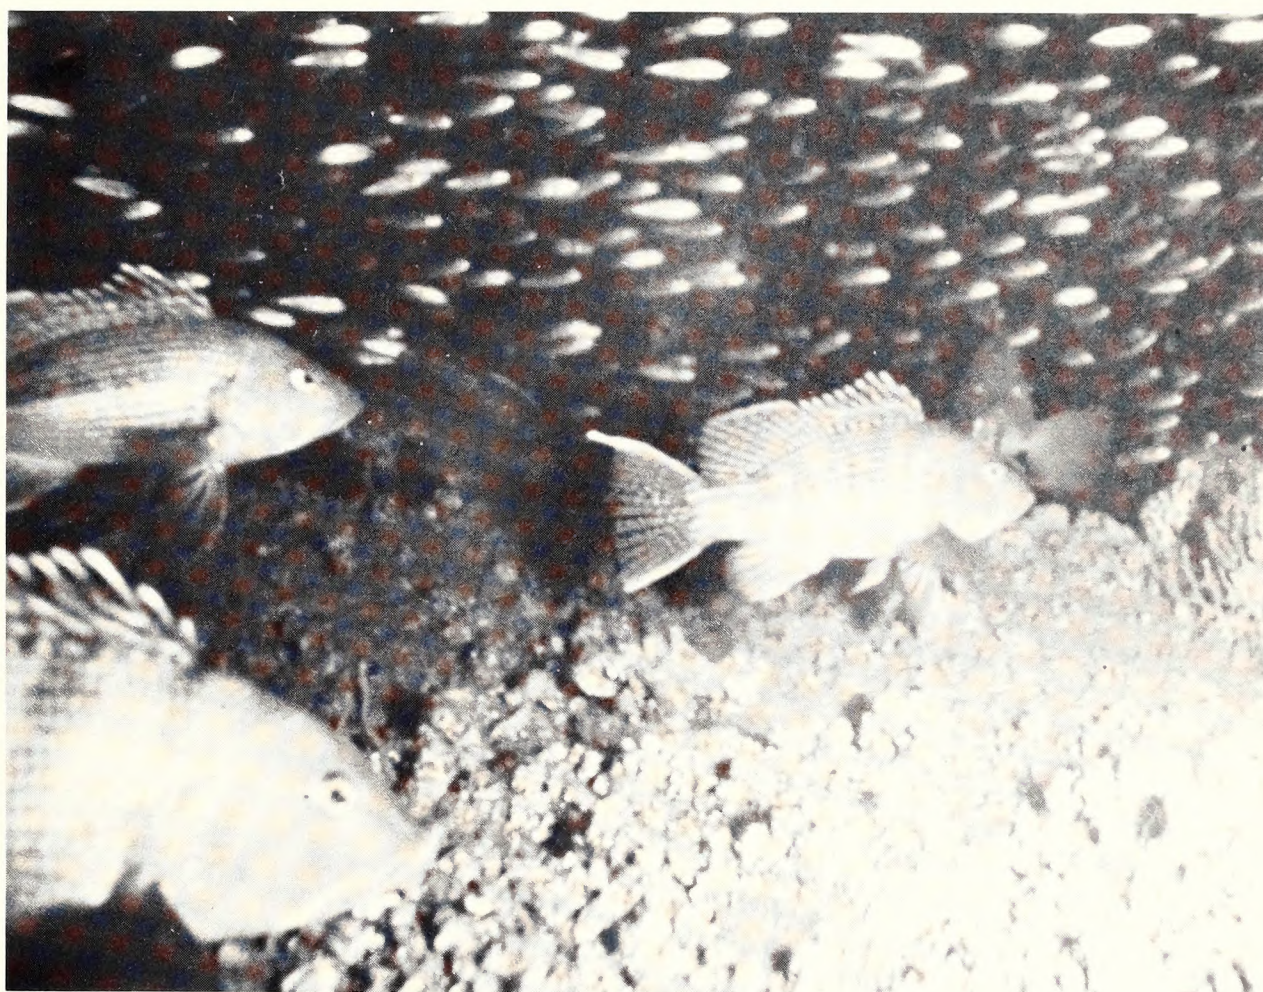
Figure 42. The first horizontal photograph of the Monitor taken forward of the amidships bulkhead revealed the extent and nature of fouling at the site.

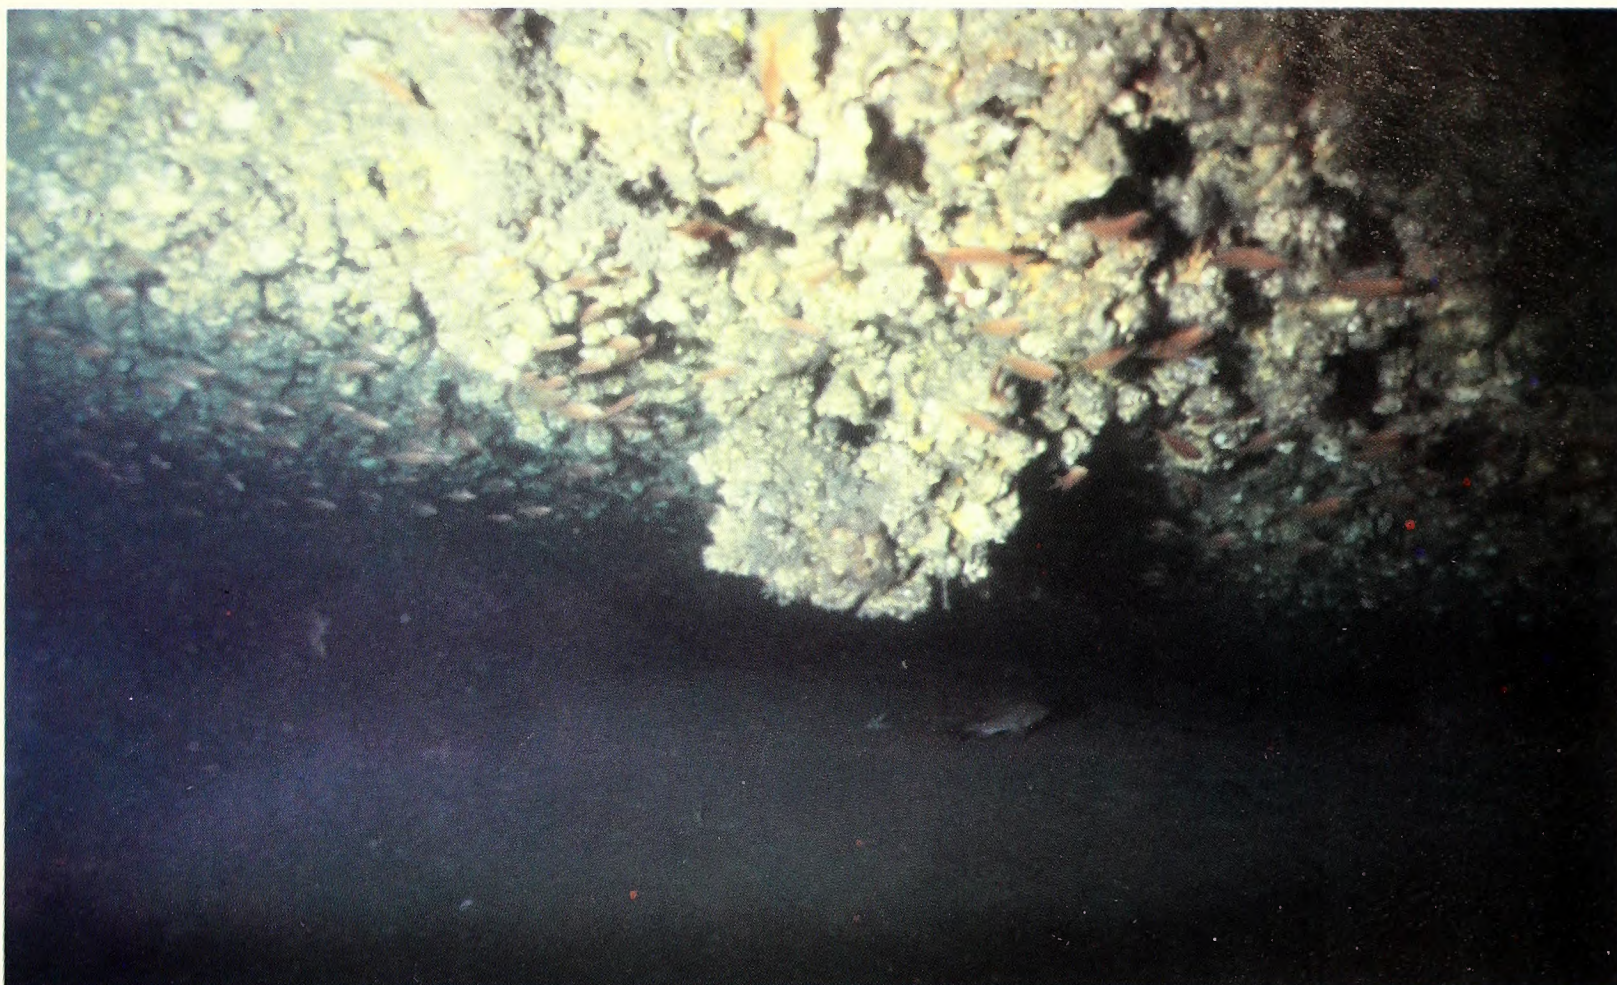
Figure 113. A heavily-fouled pad eye was located inboard of the armor belt on the port side. Also visible in the background of the photograph is the base of the armored pilot house.

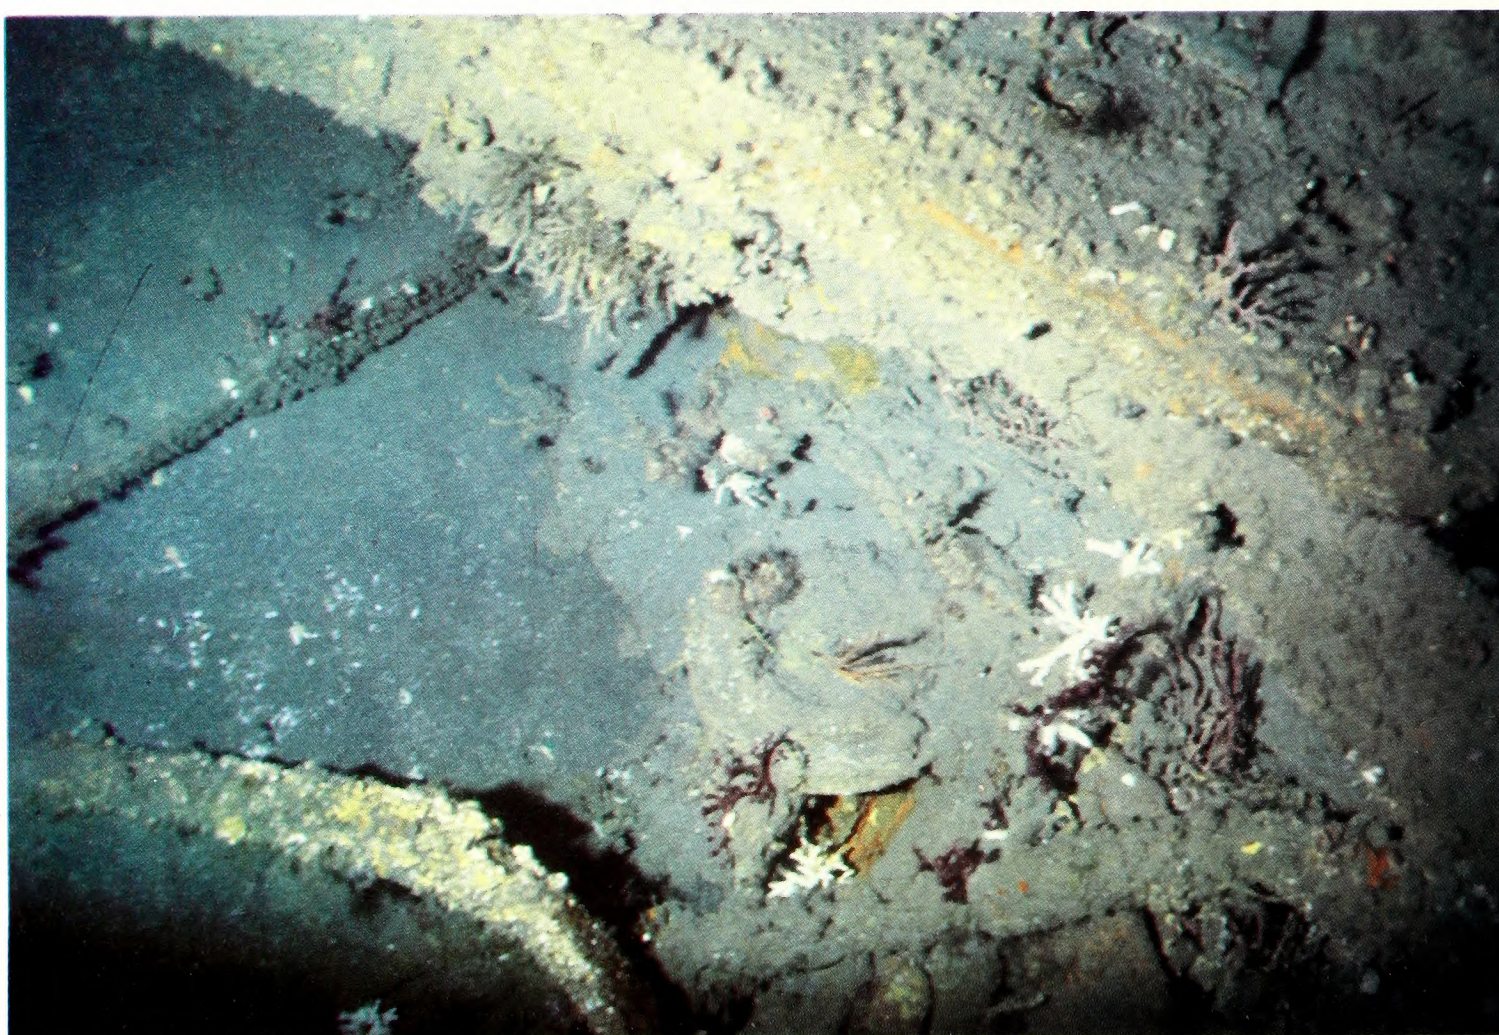
Figure 114. To the right of center, a brass-mounted glass deck light penetrates the deck of the Monitor adjacent to one of several holes in the armored "raft."

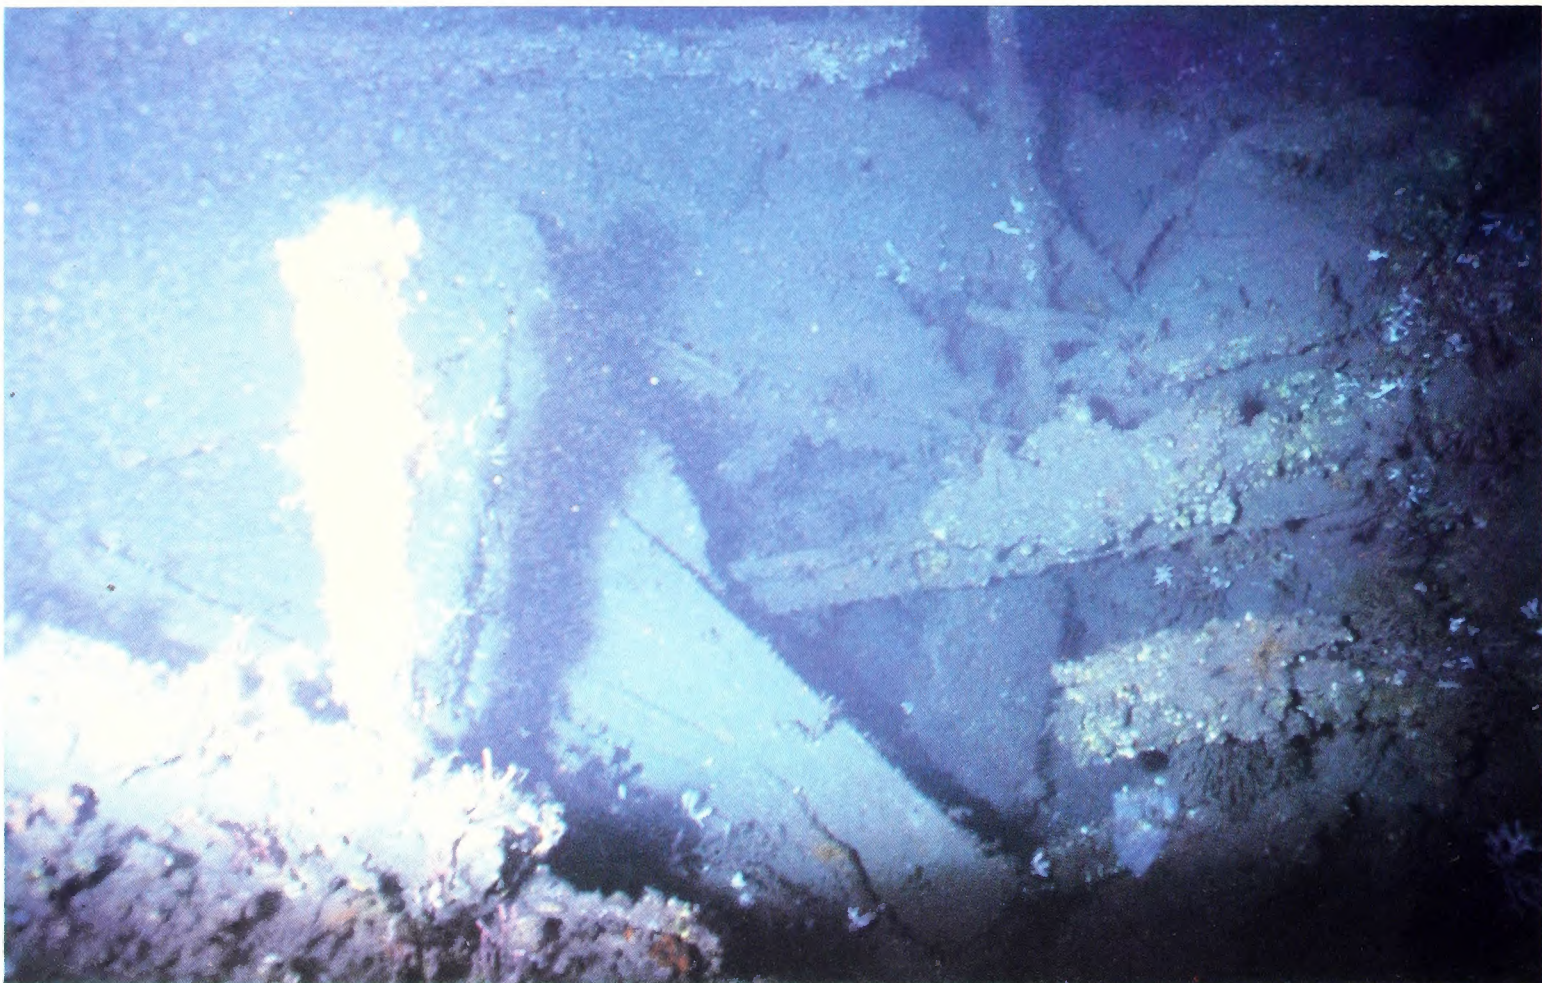
Figure 116. Immediately inboard of the port armor belt and forward of the amidships bulkhead, damage to the armored "raft" has left a substantial hole in the deck structure.

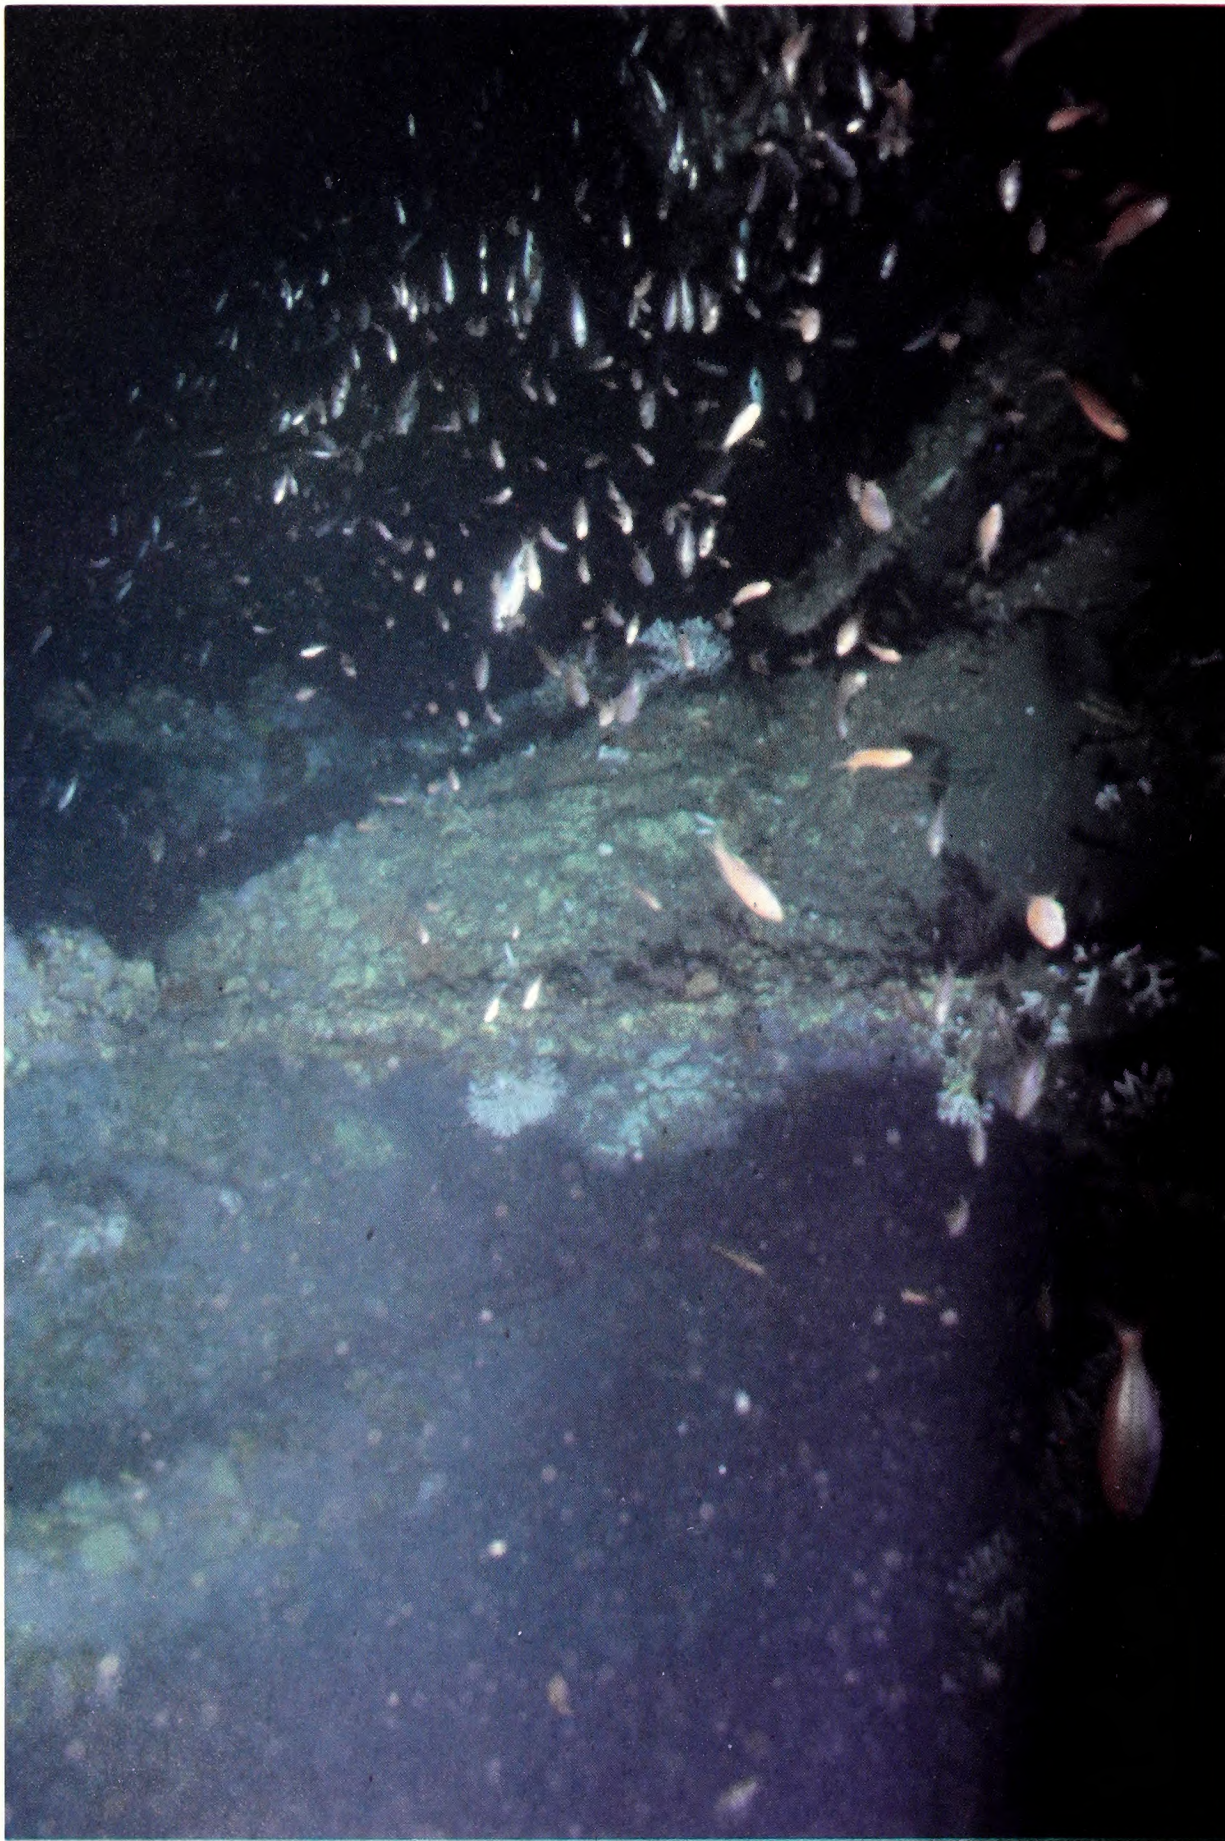
Figure 117. A reinforcing yoke attached to the amidships bulkhead served to reinforce the hull and support the turret. A wedge, located at the bottom of the photograph, "keyed" the turret up to permit rotation and training of the guns. To the left and right of the wedge the remains of the galley stove were identified.

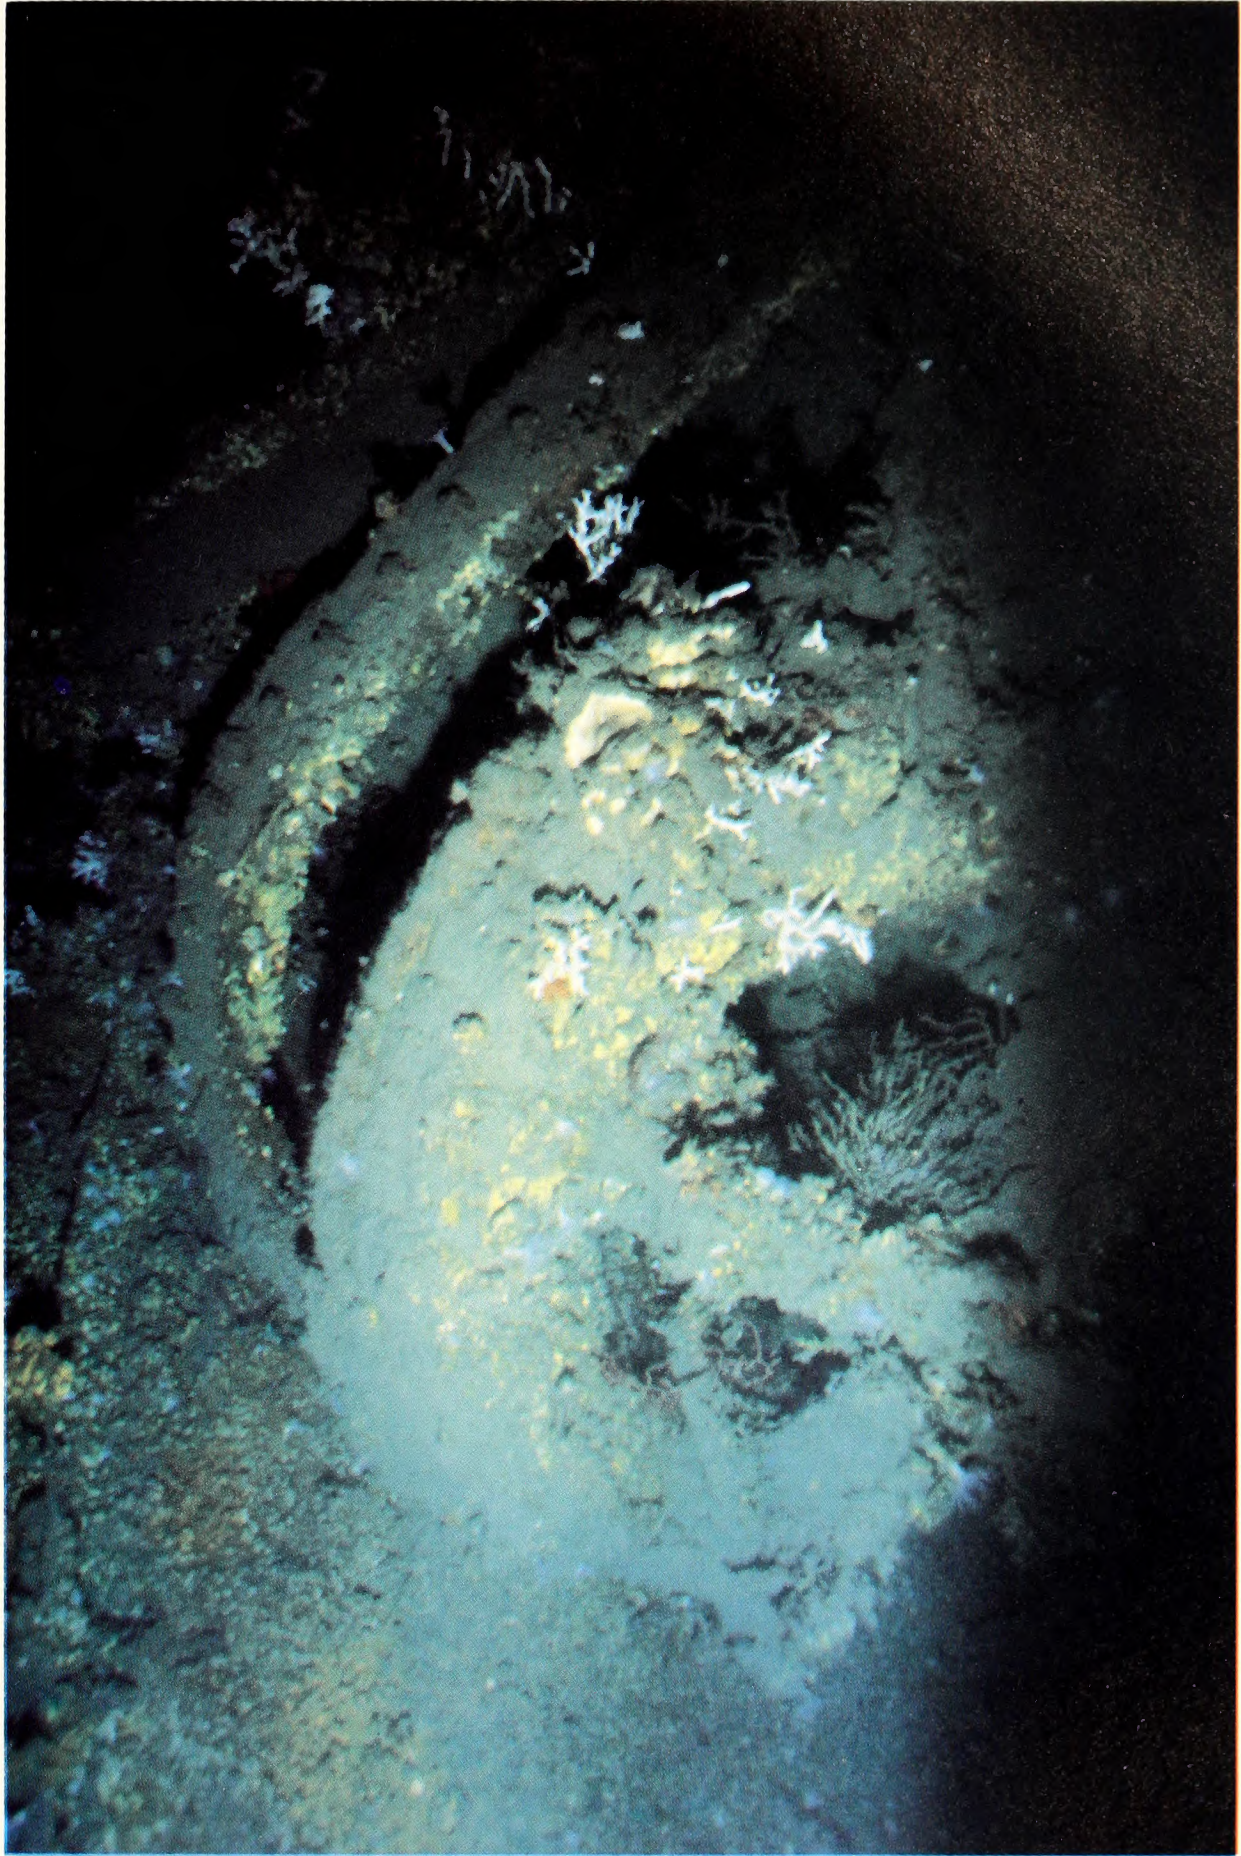
Figure 118. The remains of a centrifugal pump lie immediately forward of the port boiler. Framing for the port airtight amidships bulkhead door lies to the right of the pump.

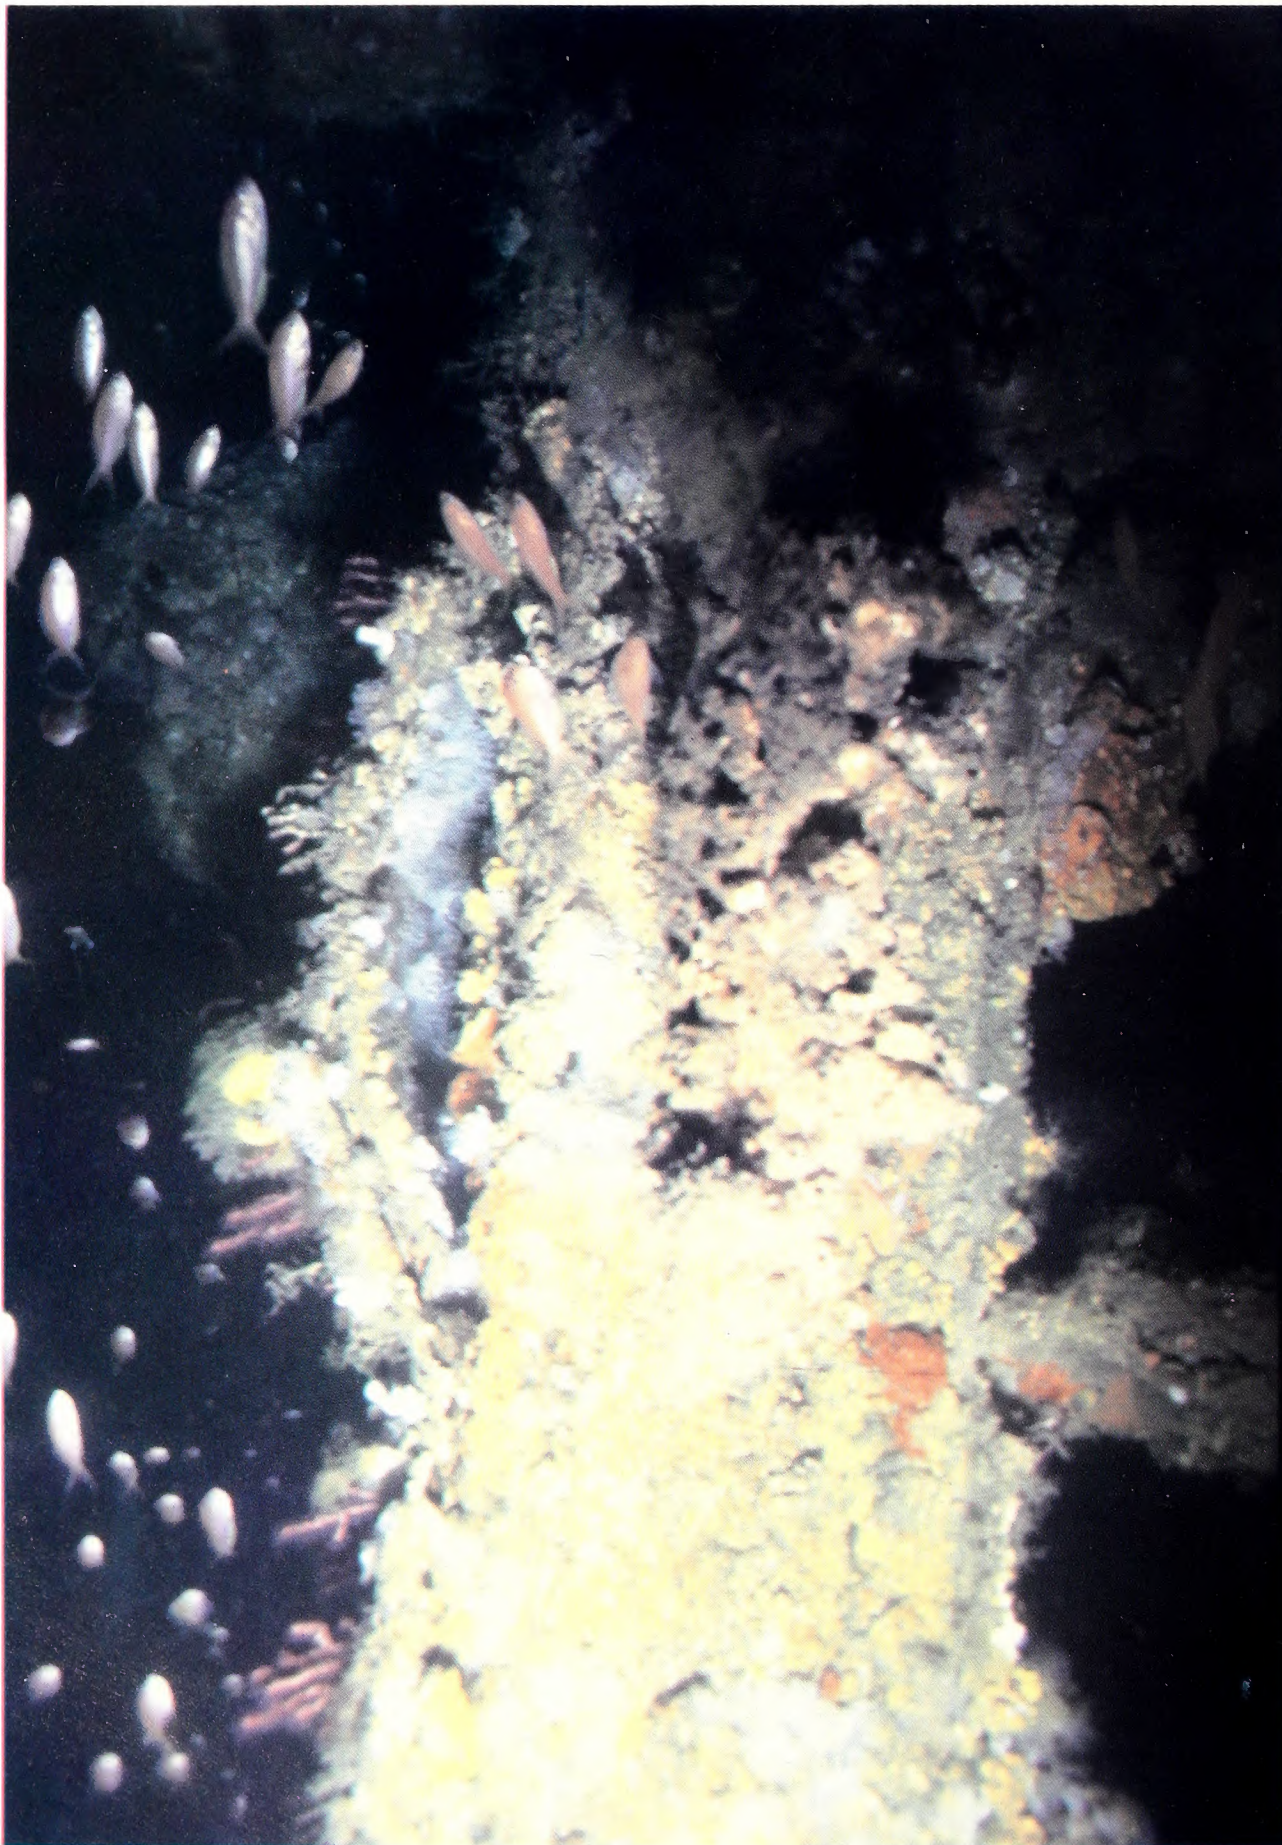
Adjacent to the deck-related damage, the amidships bulkhead was found to have deteriorated completely to a point on the vessel's center line where a heavy yoke was positioned to support the turret shaft (*Figure 117*). The frame for the port water tight door that provided access to the engineering space and galley was found resting on the remains of a large centrifugal pump or blower mounted to the overhead forward of the port boiler (*Figure 118*). Aft of the turret support yoke, remains of the iron galley stove were identified. Starboard of the turret support yoke, the amidships bulkhead was still intact although portions of the plating had deteriorated. A wedge designed to raise the turret for rotation was found intact on the yoke and an examination of the bottom plating on the lower hull adjacent to the yoke confirmed that plates along the center line of the vessel had been formed to create a false keel (*Figure 119*).

Figure 119. The *Monitor's* false keel, formed from contoured sheet iron, provided a water course below the floors along the longitudinal axis of the vessel. The false keel, photographed at the amidships bulkhead looking aft, provided the only features on the otherwise flat bottom of the vessel.
